Enhanced Preliminary Assessment Report:

Manassas Army Housing Units
Independent Hill, Virginia

October 1989

Environmental Research Division
Argonne National Laboratory
Argonne, Illinois 60439

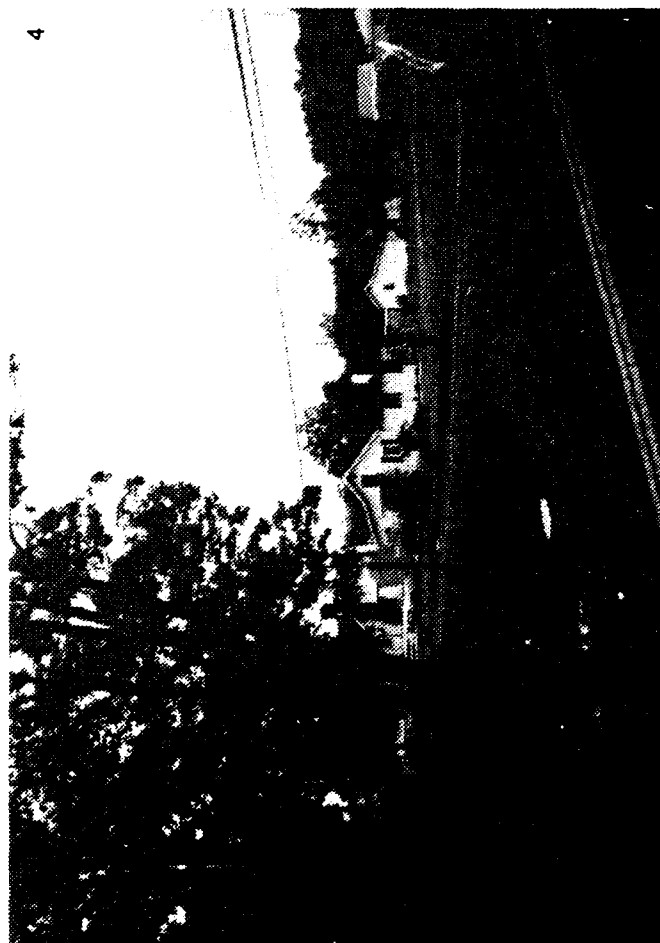
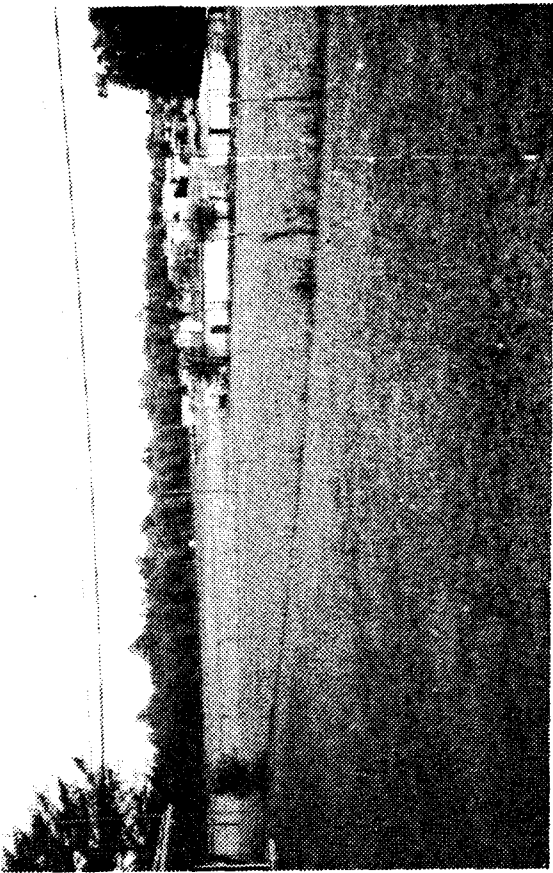
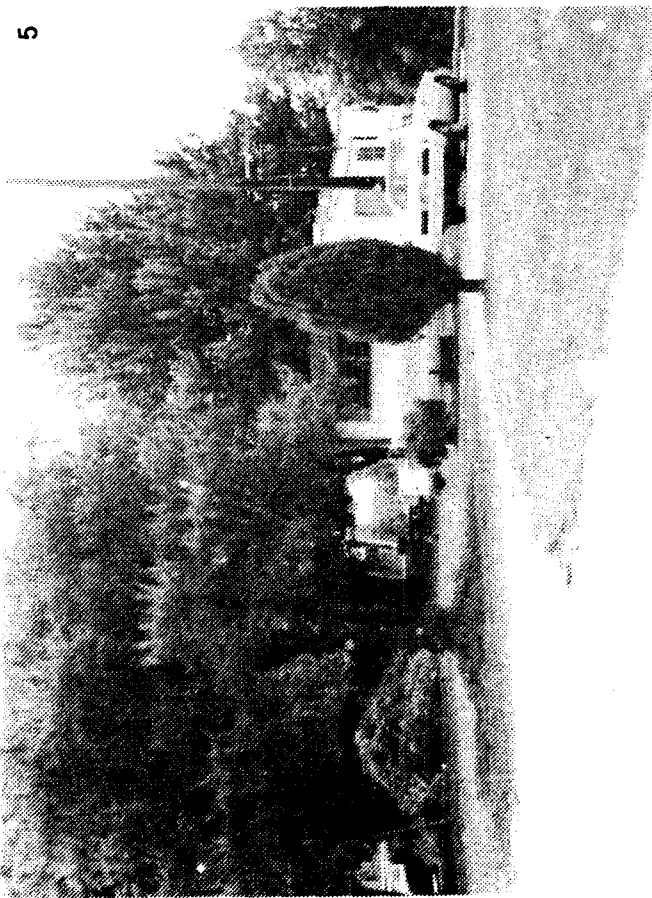
APPENDIX:
PHOTOGRAPHS OF MANASSAS HOUSING FACILITY
AND SURROUNDING LAND

1. One of the Army housing units on Route 619.
2. Electrical transformers mounted near the top of a utility pole; transformers are the responsibility of the local utility company.
3. Playground area for children.
4. Private homes in the vicinity of the Army housing units; the homes lie to the northeast of the housing area.
5. Private trailer park, north of the area.
6. Buildings behind the fenced area belong to the Prince William County School District; that area was formerly occupied by a Nike operation and is south of the housing area.
7. Cemetery grounds just west of the housing area.
